THE DURAND MINE

FIRST WORLD WAR TUNNEL SYSTEM IN THE GRANGE AREA

THE CANADIAN MEMORIAL PARK, VIMY

REPORT ON THE DURAND MINE AT VIMY

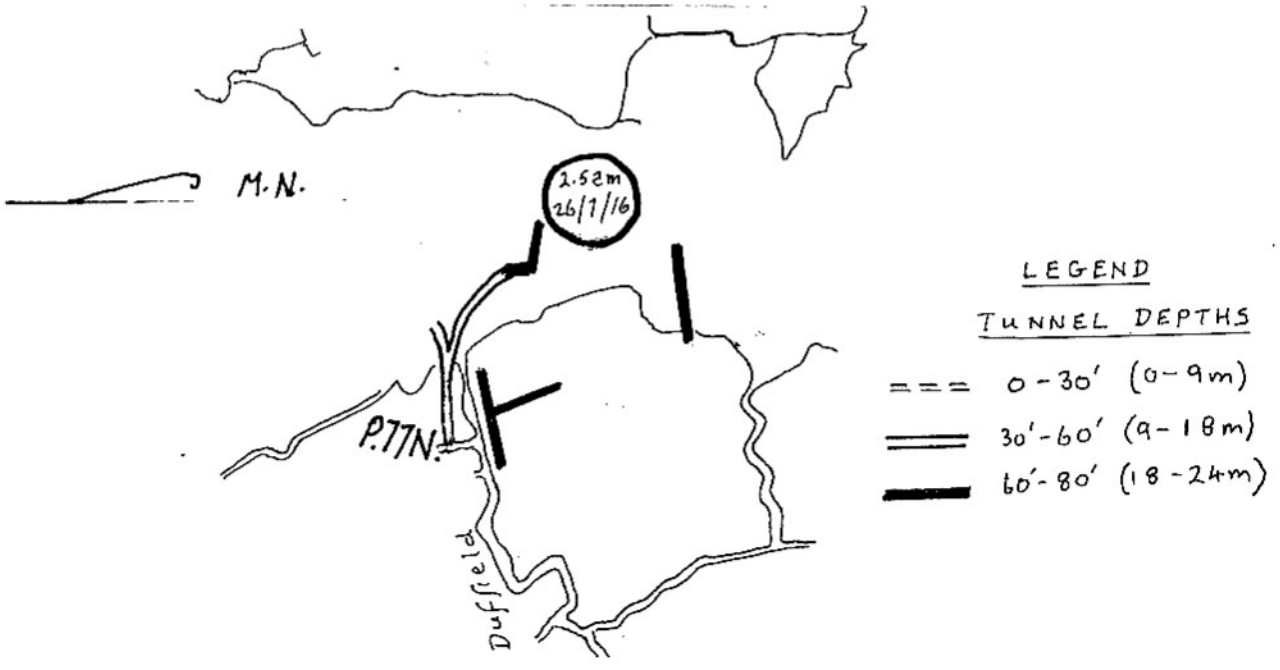
P77N was damaged by the blow, but no gas could be detected. The left gallery is badly shaken and partially filled in, but is still open to the face and should be clear in 24 hours. The right gallery is nearly filled in, with loose chalk, but appears open to the last bend. It should now be possible to re-open and continue there to protect the near lip of the new crater.

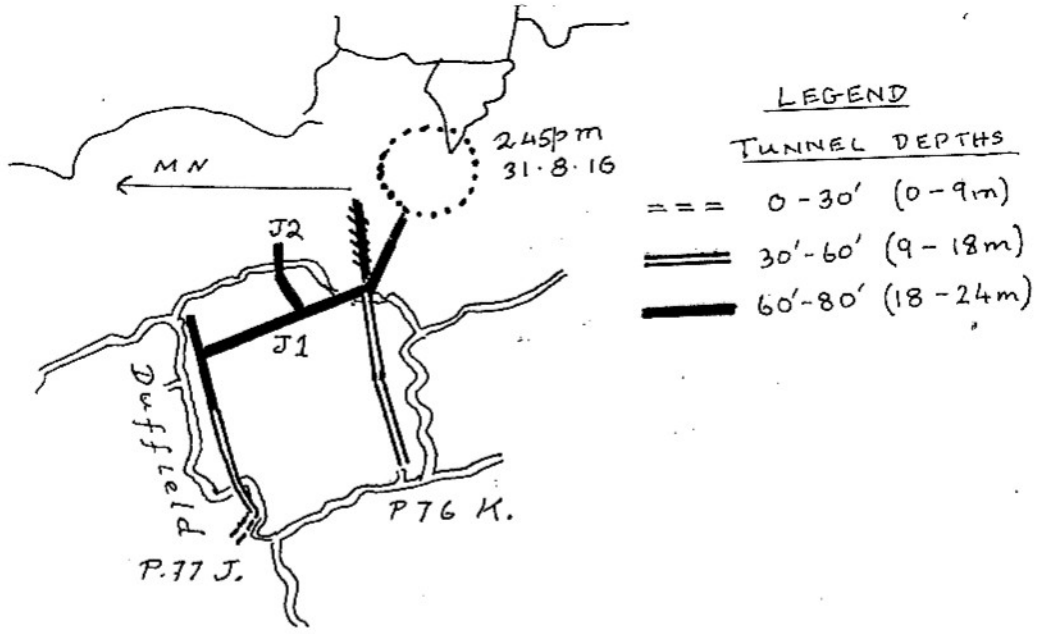
a. On 31.8.16 a heavy camouflet was fired by the Germans against a new right hand fork of P76K, as illustrated in the diagram below. This did comparatively little damage but resulted in the death by gassing of 136485 Sapper Follows E and admission to hospital of 112678 Sapper Adams C.

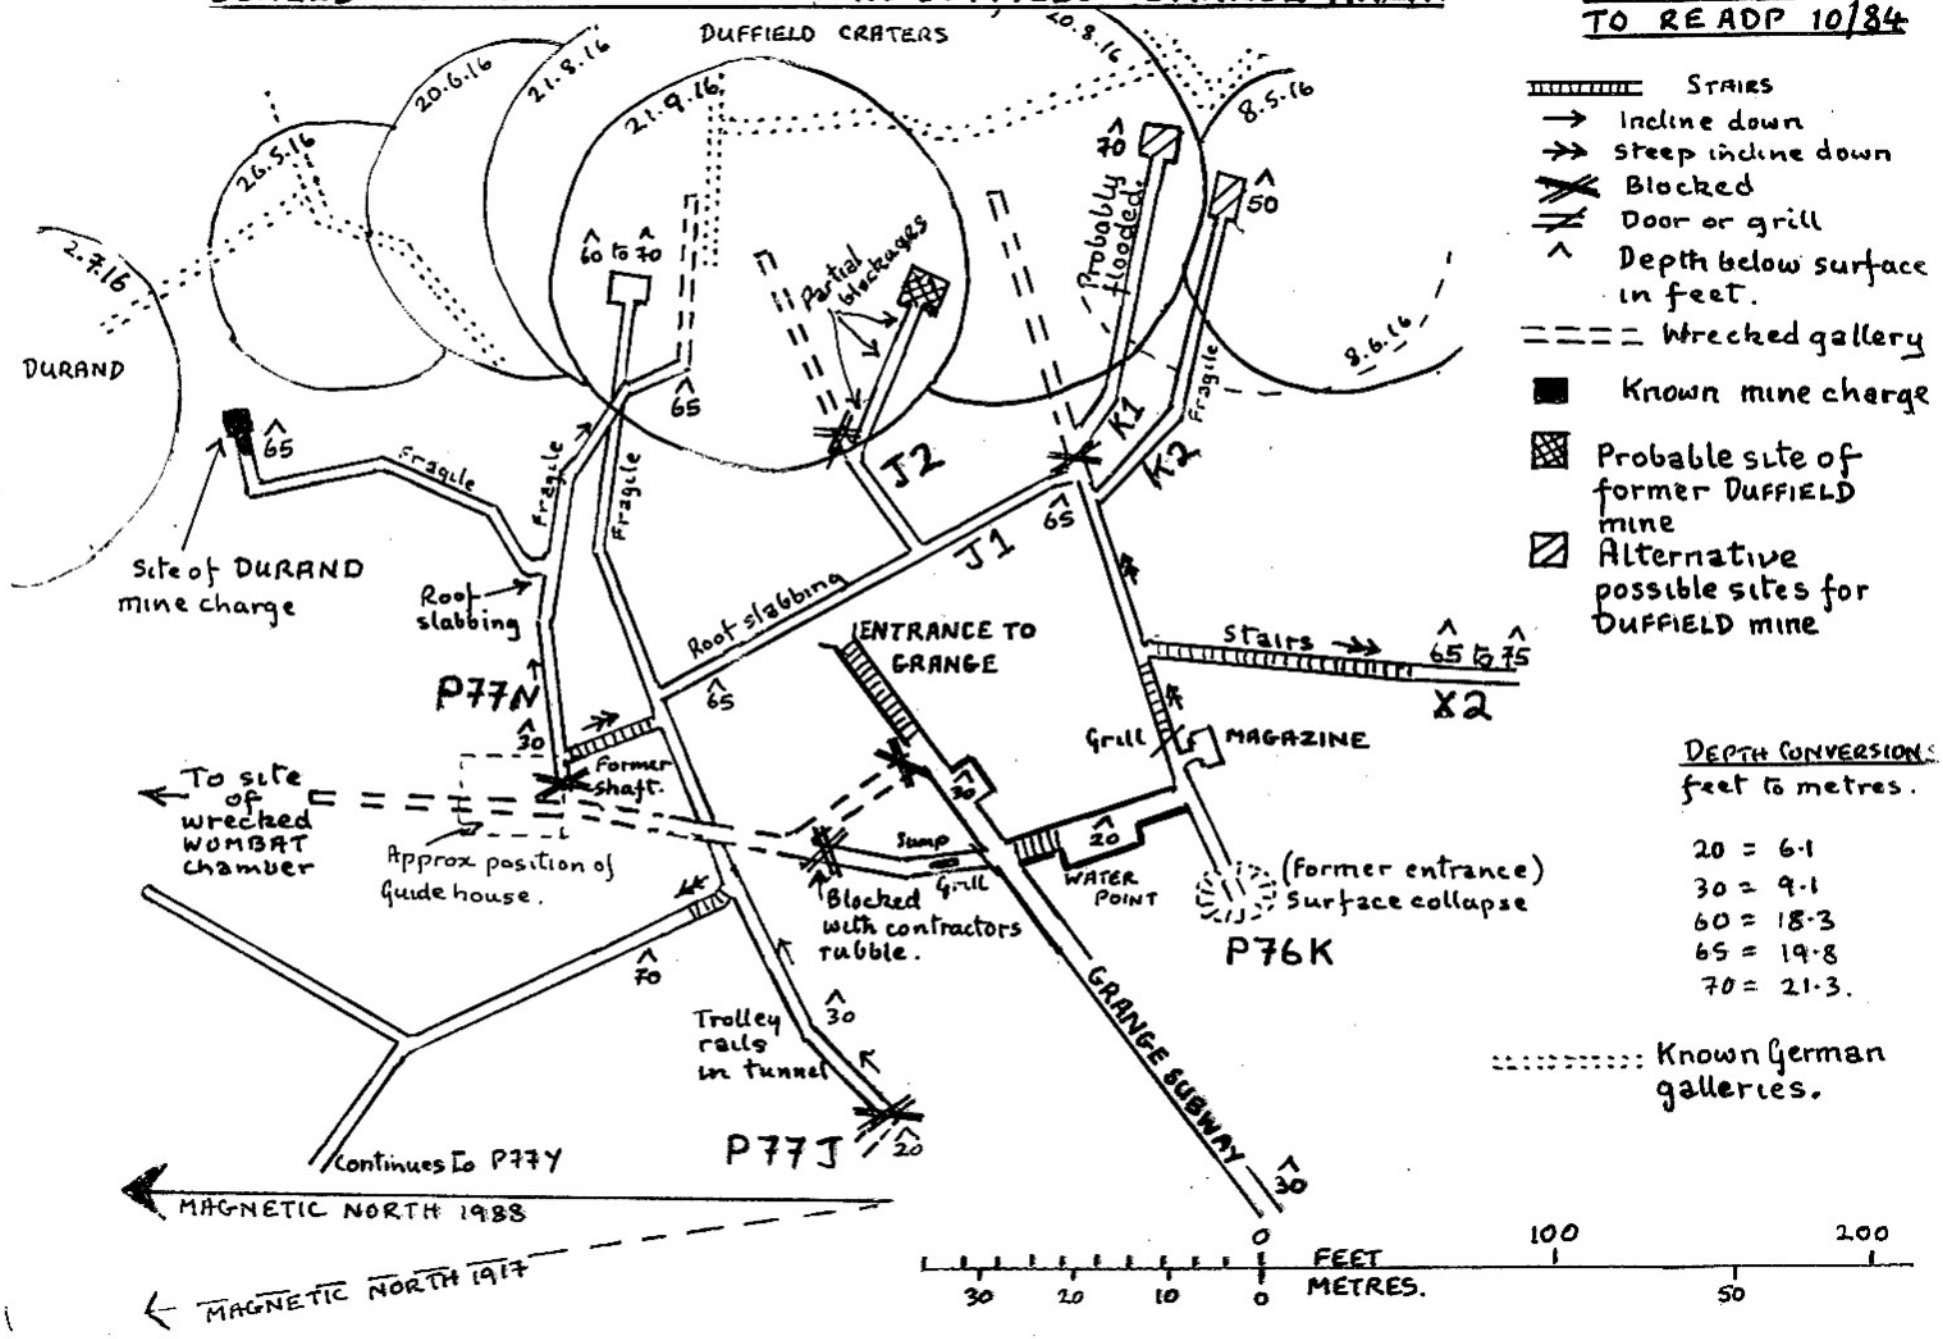
DIAGRAM 1
TO READP 10/84

SCALED DIAGRAM OF TUNNELS IN DUFFIELD - GRANGE AREA.

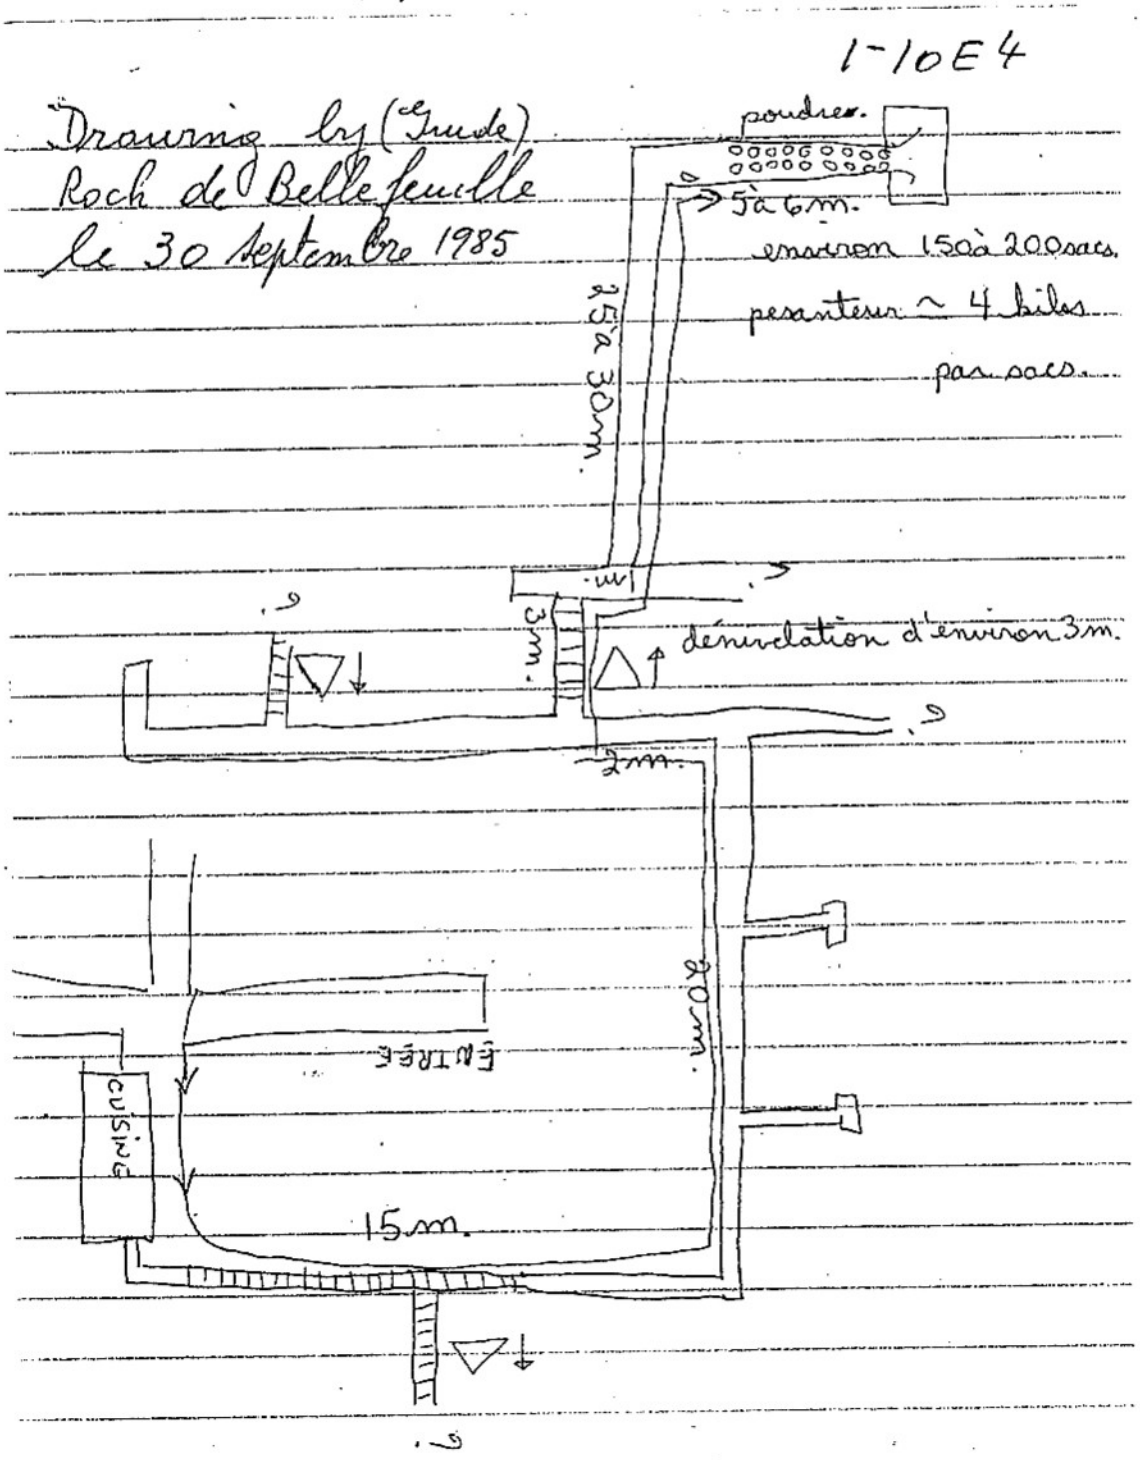
DIAGRAM 2
TO RE ADP 10/84
DATED 31 JAN 89

4. Discovery of the Mine Charge. In 1985 a Canadian Historian induced one of the GRANGE guides to give him access to the fighting tunnels and accompany him on an impromtu exploration. Lacking a plan of the workings they appear to have randomly investigated some of the tunnels leading off the laterel going to the North of the GRANGE Subway and thus entered the DURAND mine tunnel. On return to the surface they reported to the Superintendent of the Canadian Memorial Park (M. Pierret) that they had found at the head of the tunnel a cache of 150 to 200 sacks of a grey powder, presumed to be explosive. A copy of the original sketch plan is at diagram 2.

DISCOVERY OF DURAND MINE
ORIGINAL SKETCH PLAN OF ROUTE

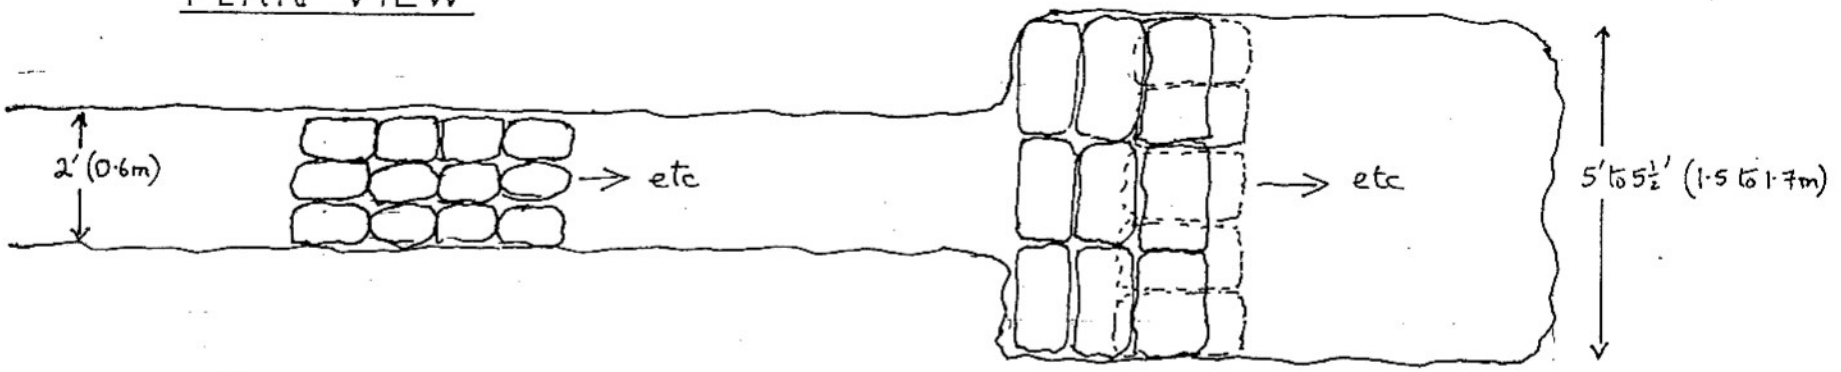
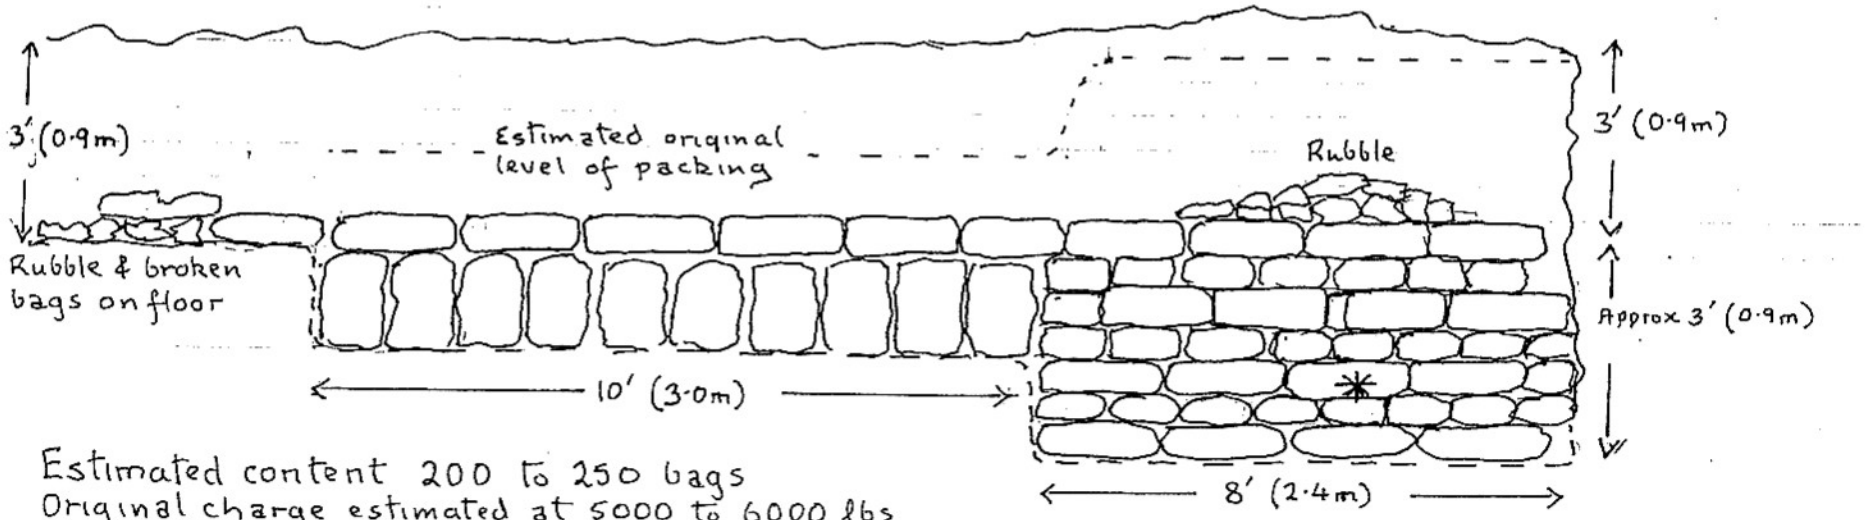
DIAGRAM 3 to
READP 10/84
dtd 31 Jan 89

e. It was apparent that the chamber floods from time to time. At one corner there was evidence of a soak away. Some slight roof collapse has occurred forming a small pile of rubble on top of the bags but there is no apparent risk of the detonators - which are well padded in the pile - being set off by further roof falls. There were no tree roots protruding into the chamber which is solid chalk without earth filled fractures.

SKETCH OF MINECHAMBER & CONTENTS.

Estimated content 200 to 250 bags
Original charge estimated at 5000 to 6000 lbs
(2250 to 2700 kg)

* Estimated position of detonators.

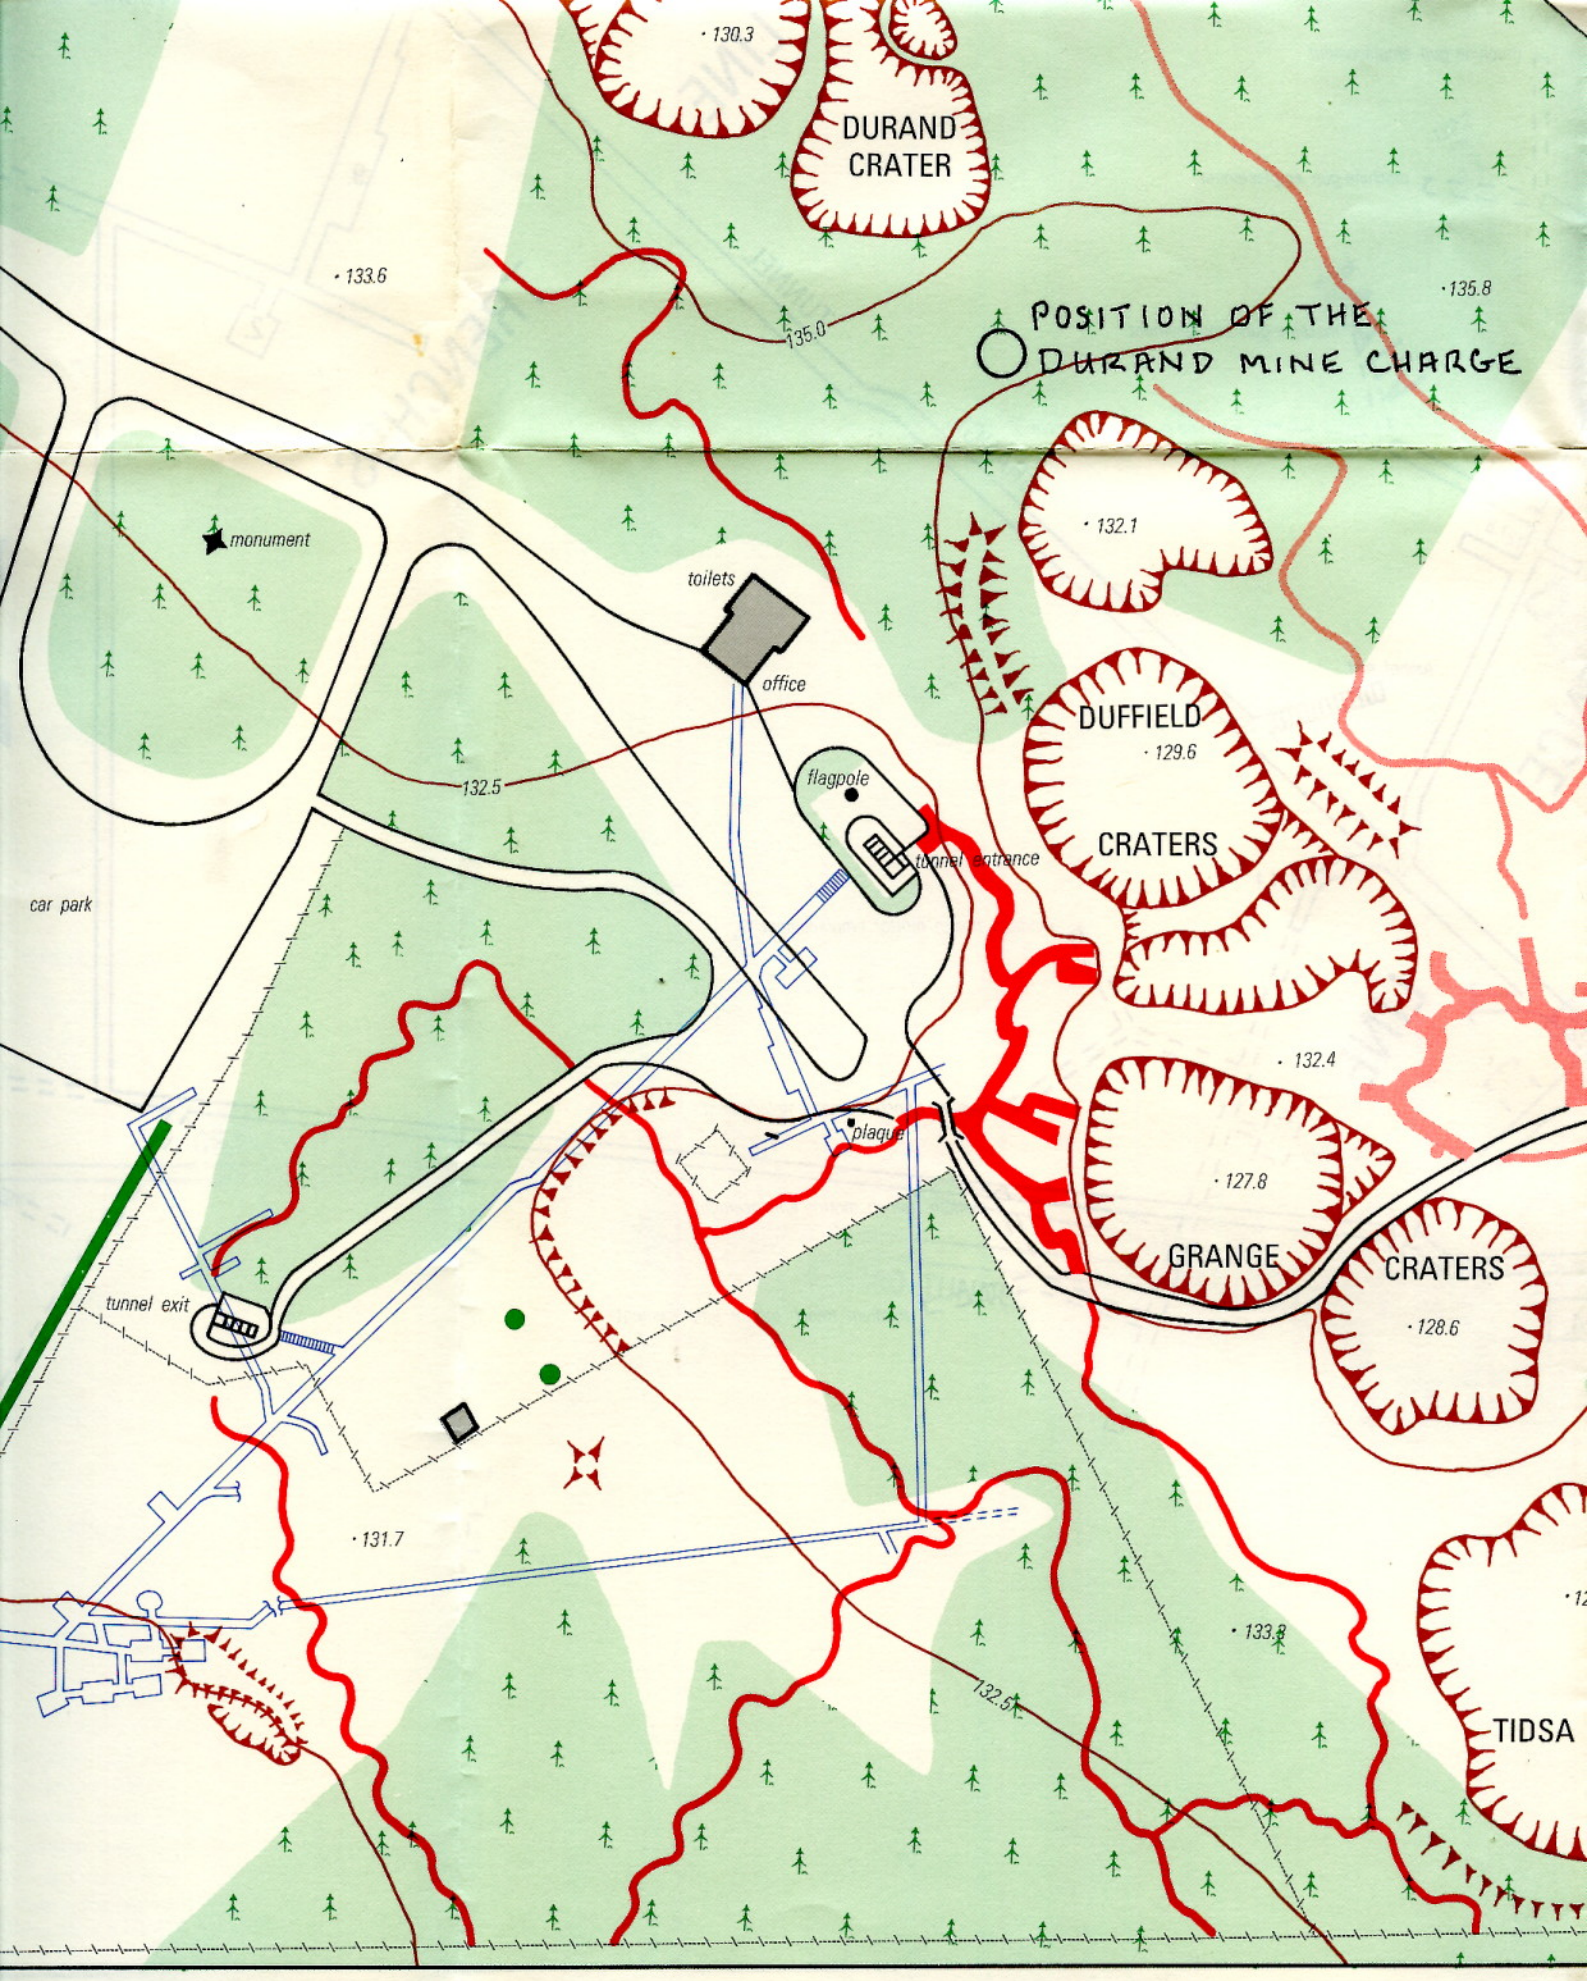
PHOTO 11

Photo 11 above :-
The area immediately above the DURAND mine looking approximately SW. The white mark in the foreground shell hole shows exact location. Roof of guides office visible at right centre.
